# Manhole Inspection Summary

Manhole # S29K\_\_075MH

Insp Date: **1/29/09 11:57 AM**

**Location** Address: **314 Penn St**

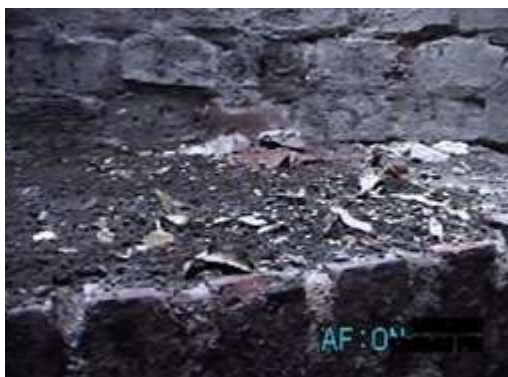
Miscellaneous

debris on bench

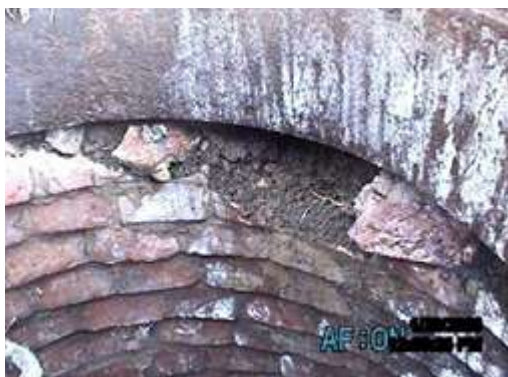
Defect 2

Condition: ☐ Sound ☒ **Cracked** ☐ Root Intrusion ☒ **Loose Brick** ☒ **Deteriorated**

Infiltration: ☐ None ☒ **Joint** ☐ Cracks ☐ Mortar ☐ Roots ☐ Wall

chimney deteriorated with cracked & loose bricks

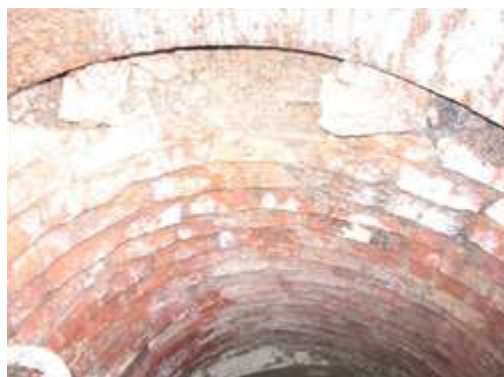
Defect 1

**Frame** Offset: **1** (in.) Condition: ☐ Sound ☐ Cracked ☒ **Leaks**

Frame Offset 1 inch

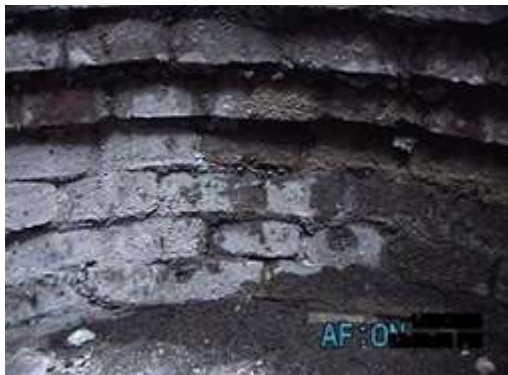
Defect 4

Infiltration: ☐ None ☐ Joint ☐ Cracks ☒ **Mortar** ☐ Roots ☐ Wall

infiltration mortar in barrel

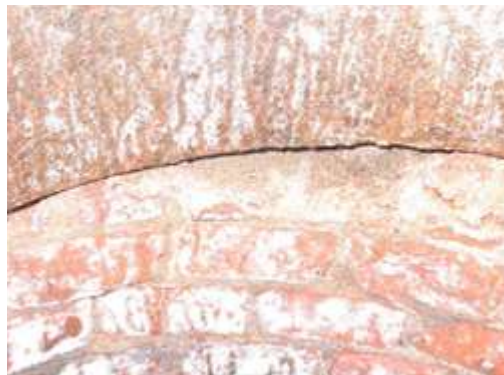
Defect 3

lid/frame infiltration

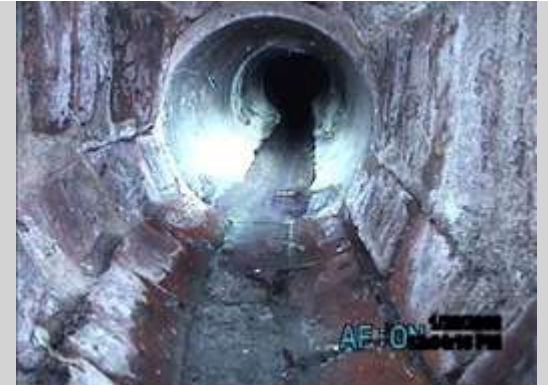
12 O'Clock Outflow

Pipe Height: **8.4** (in.) Rod and Bar (Angled)  
Pipe Material: **Clay** ☐ Pipe Lined  
Invert Depth: **7.41** (ft.) Flow Characteristics: **Slow**  
Deposits: ☒ None ☐ Mud ☐ Sludge ☐ Debris ☐ Grease  
Silt Depth: **0** (in.) Deposits Extent:  
Infiltration: **None** Pipe Seal Cond: **Sound**

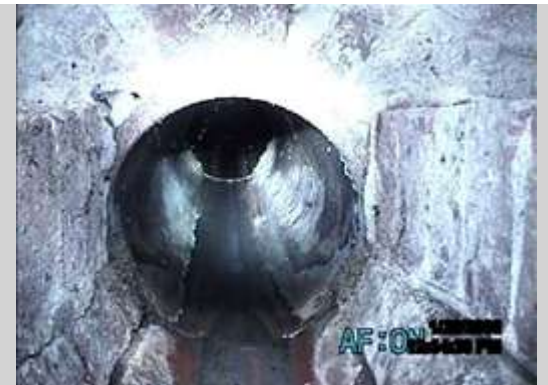
5 O'Clock Inflow

Pipe Height: **8.4** (in.) Rod and Bar (Angled)  
Pipe Material: **Clay** ☐ Pipe Lined  
Invert Depth: **7.34** (ft.) Flow Characteristics: **Slow**  
Deposits: ☒ None ☐ Mud ☐ Sludge ☐ Debris ☐ Grease  
Silt Depth: **0** (in.) Deposits Extent:  
Infiltration: **None** Pipe Seal Cond: **Cracked**
